# Practical Experience with SFRA Technique

Rafal Zaleski  
Principal Transformer Engineer  
Doble Engineering

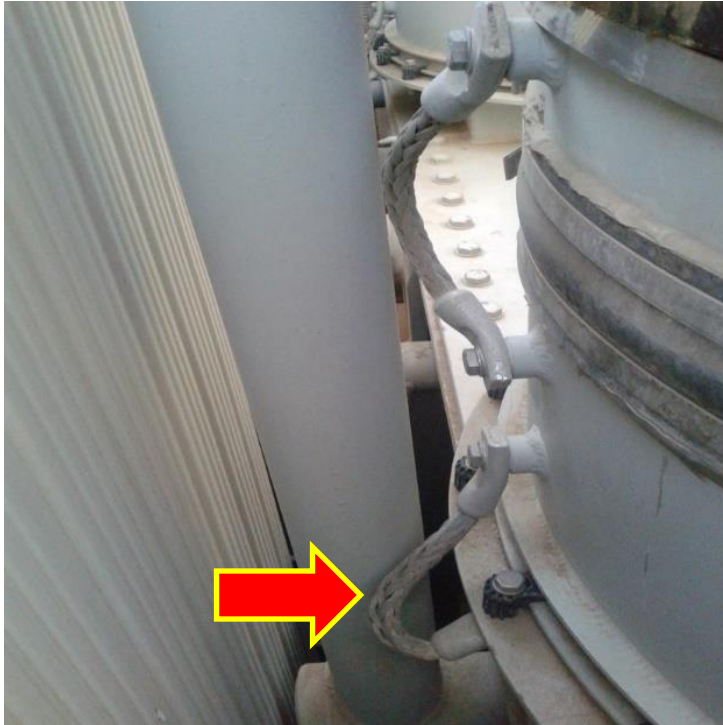
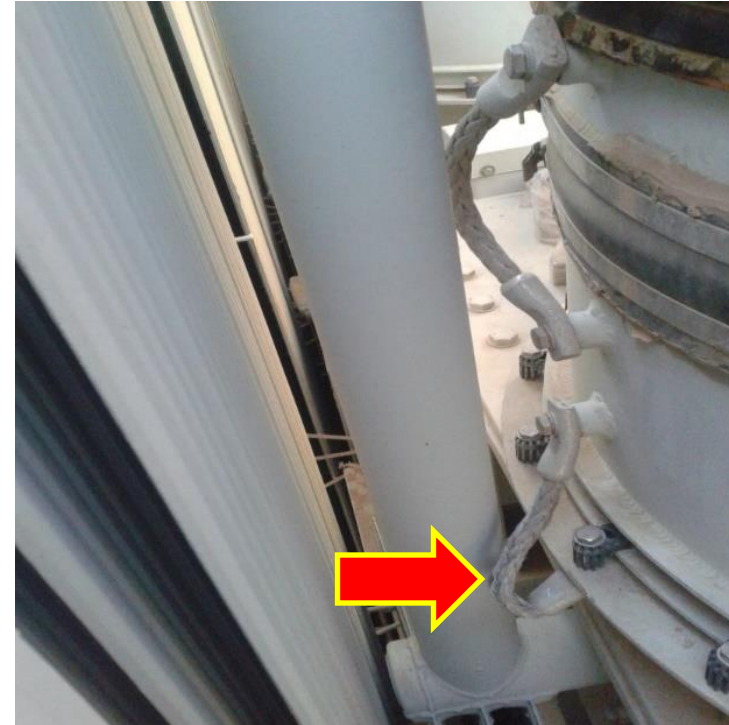
Can you spot difference between the two grounding braids?

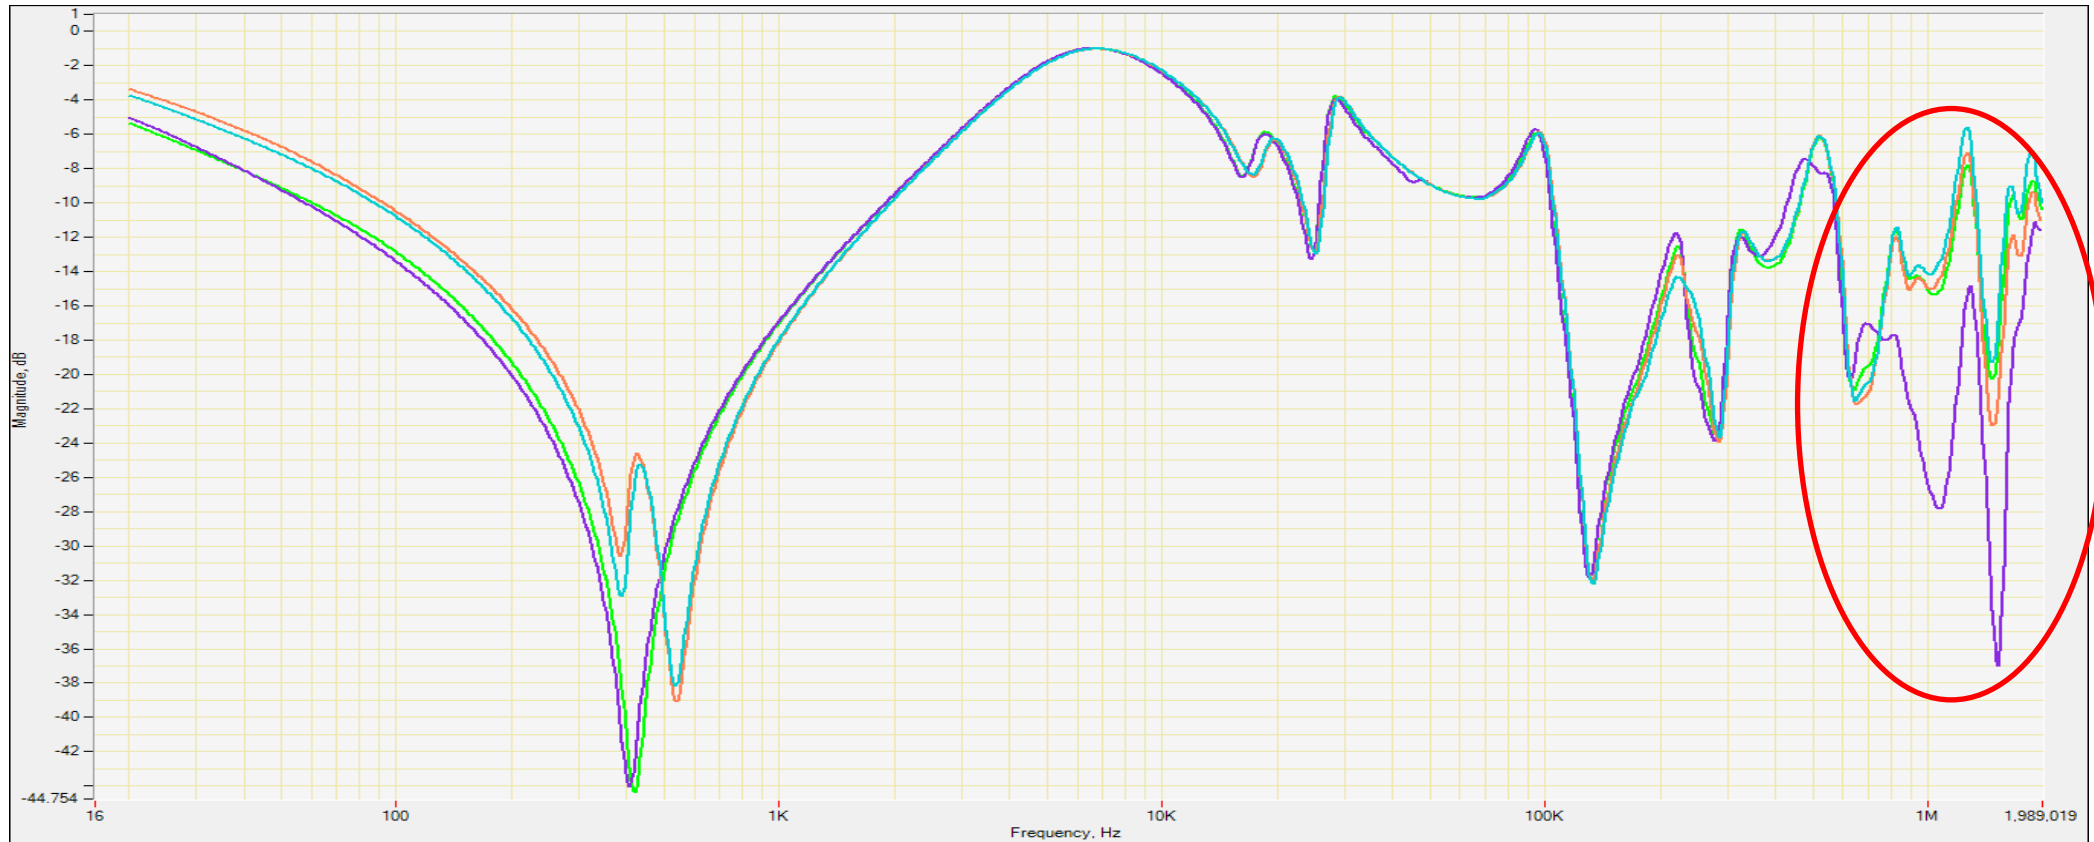
...one was not correctly earthed

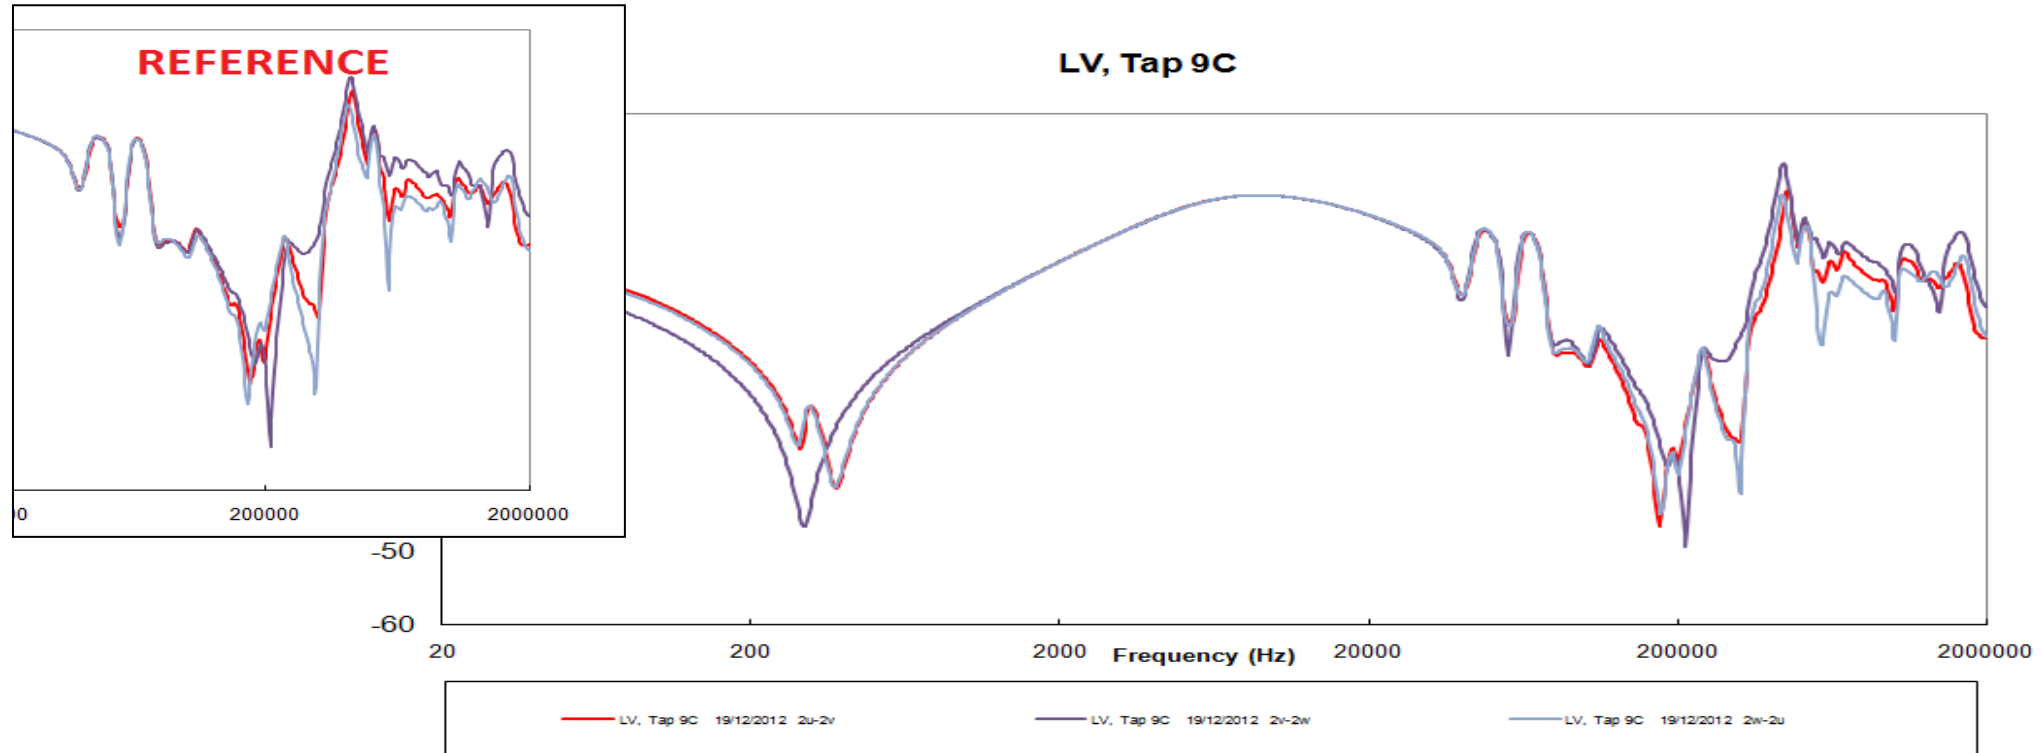
Suspicious difference was measured at LV side. Sister transformer was available to obtain reference but it was connected to HV cables.

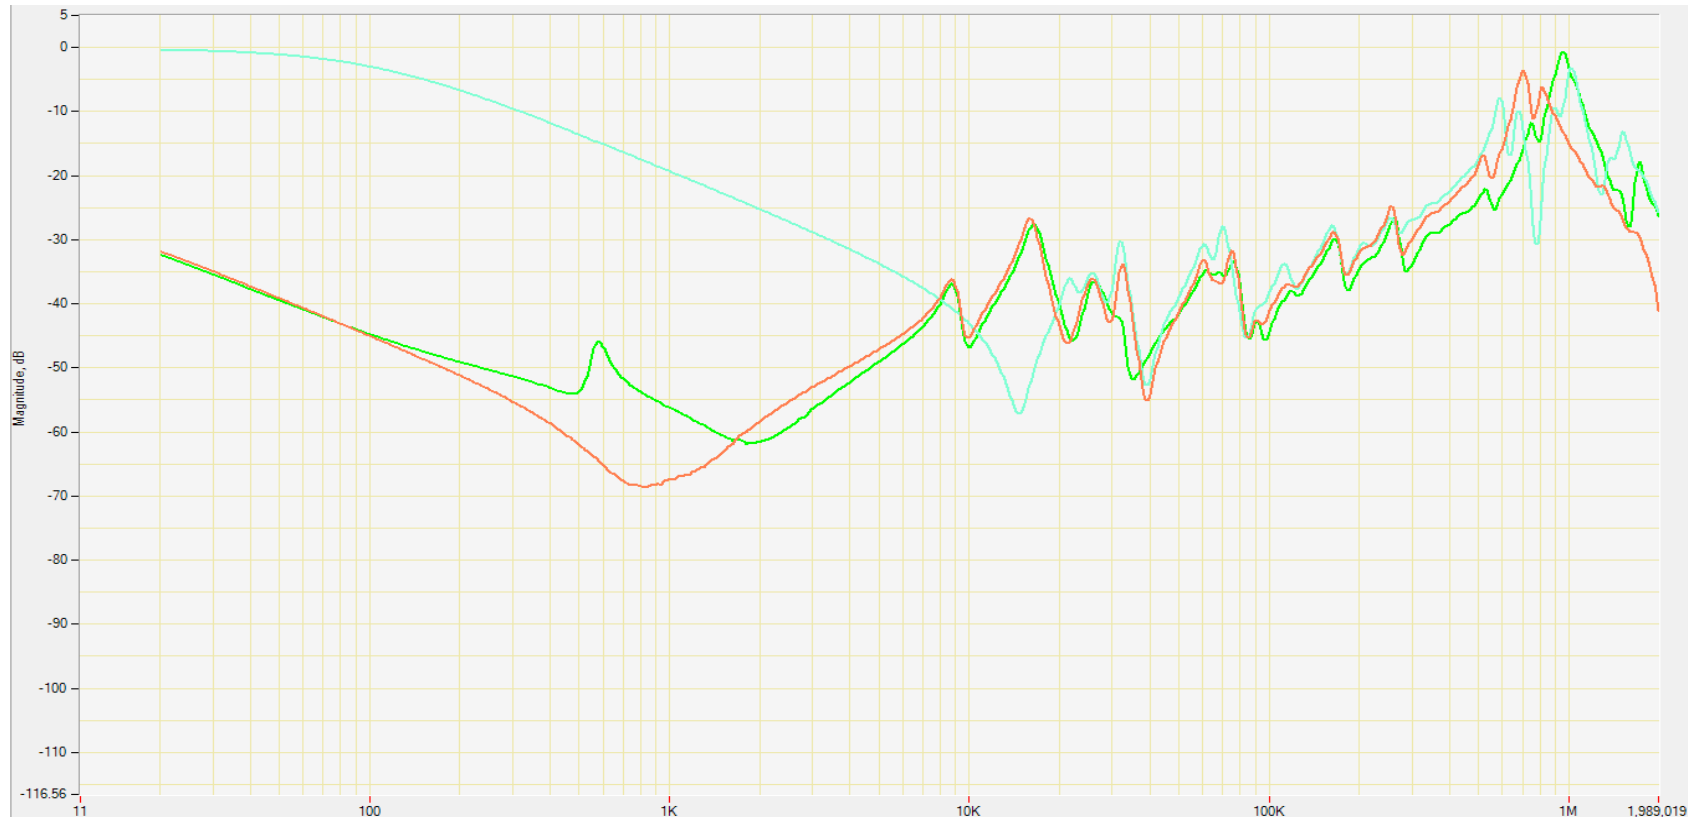
# Shorted turns

750MVA, 380/230/13.8kV autotransformer YNay0d11, failed in service

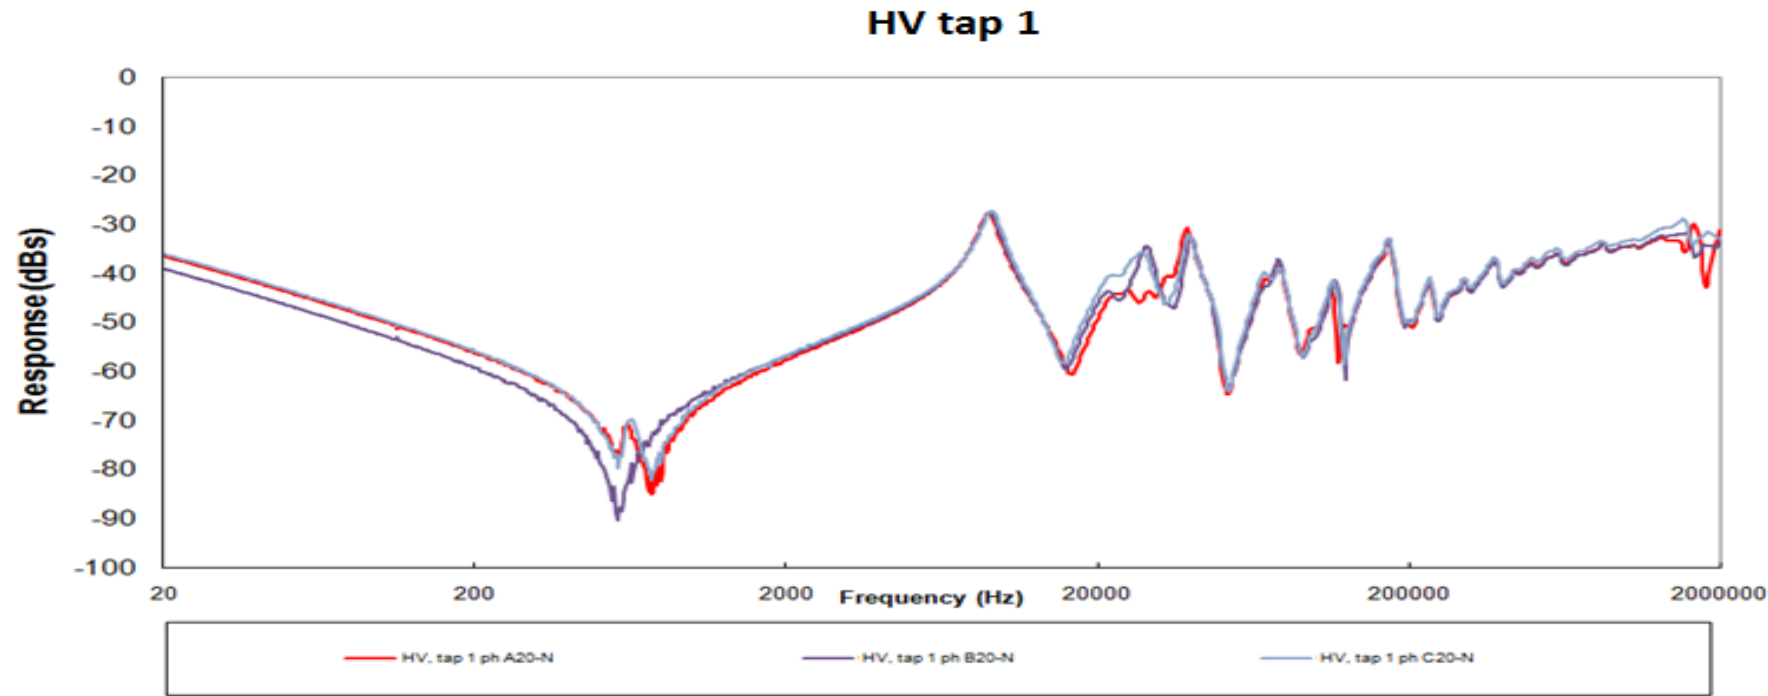
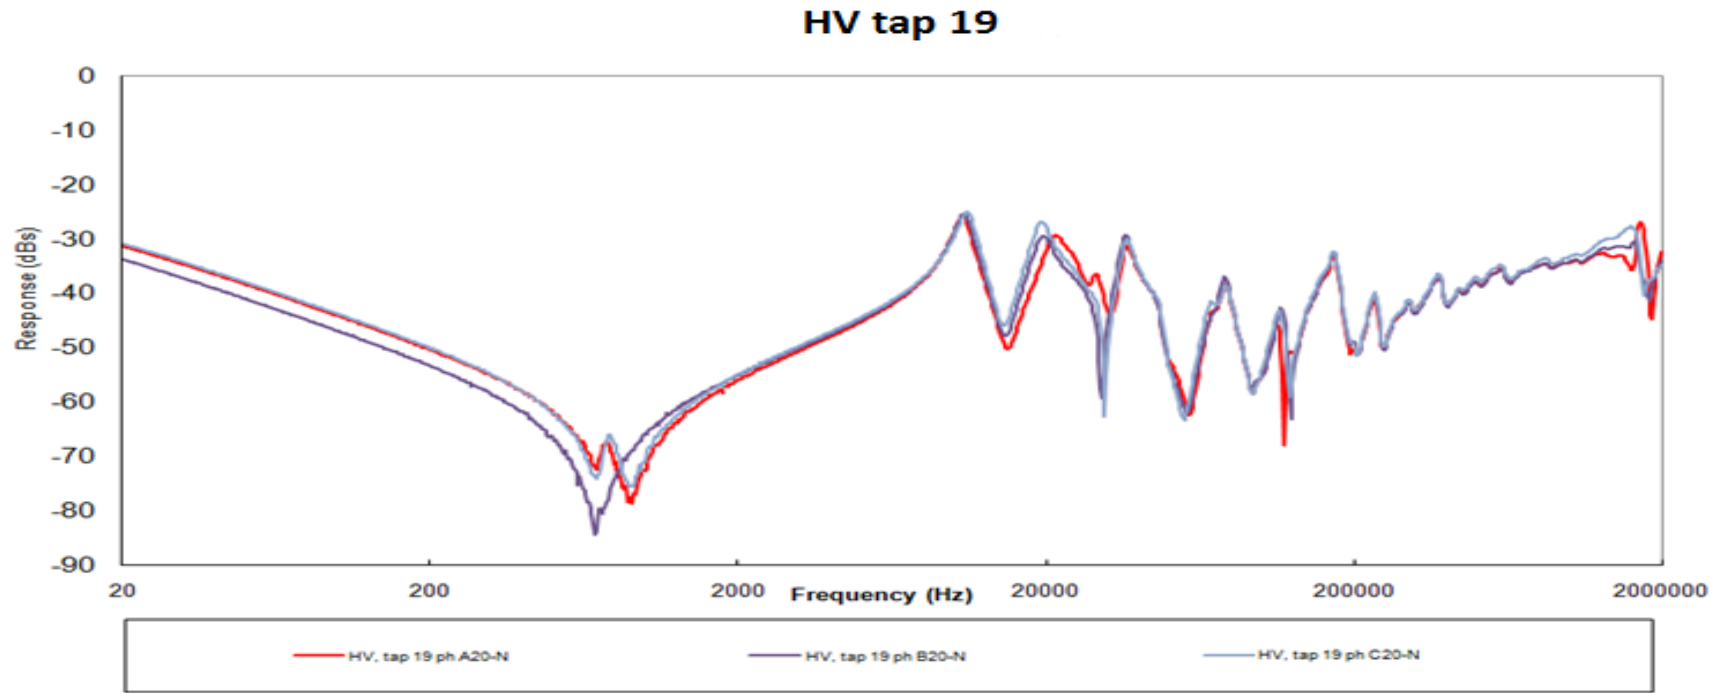
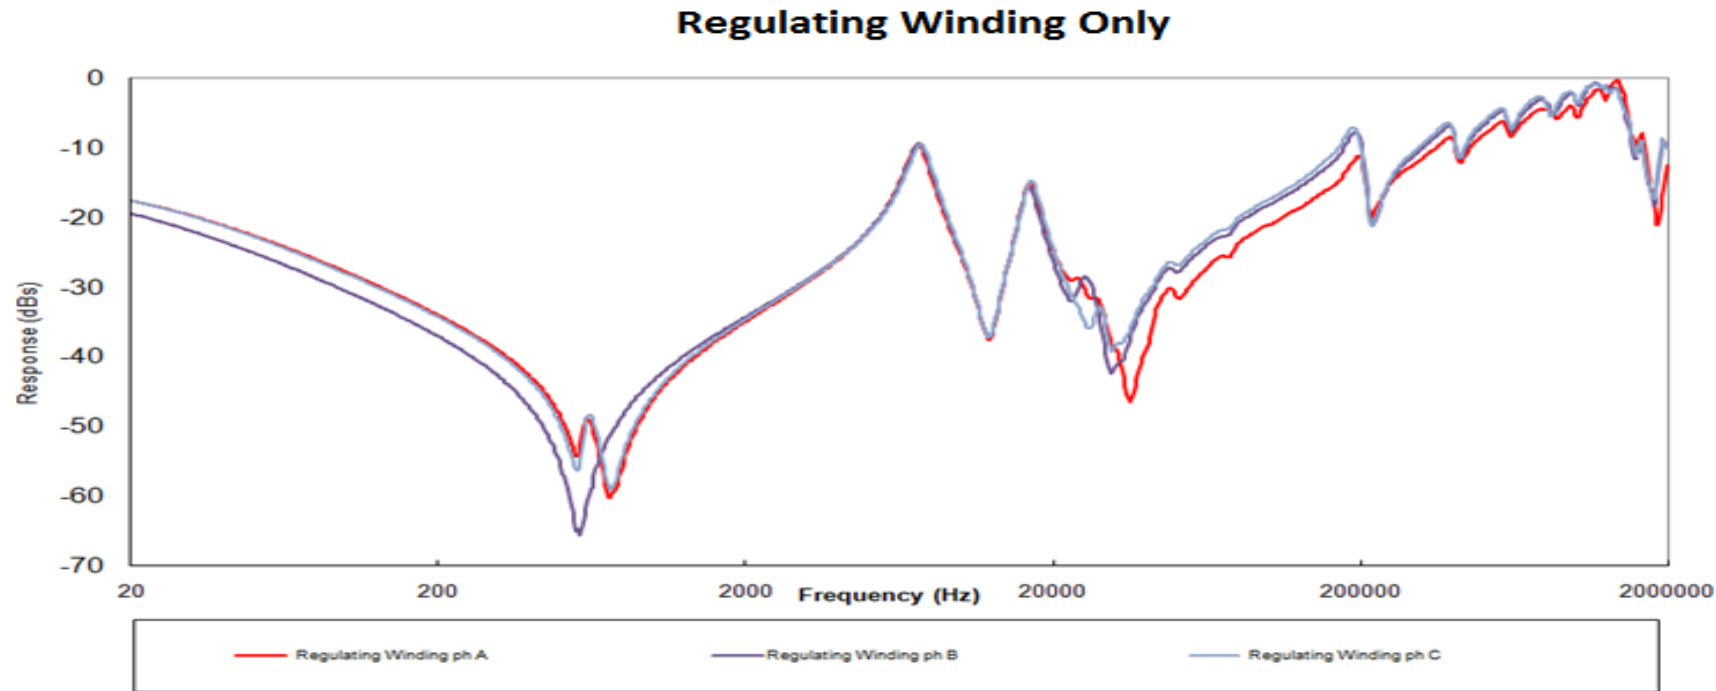
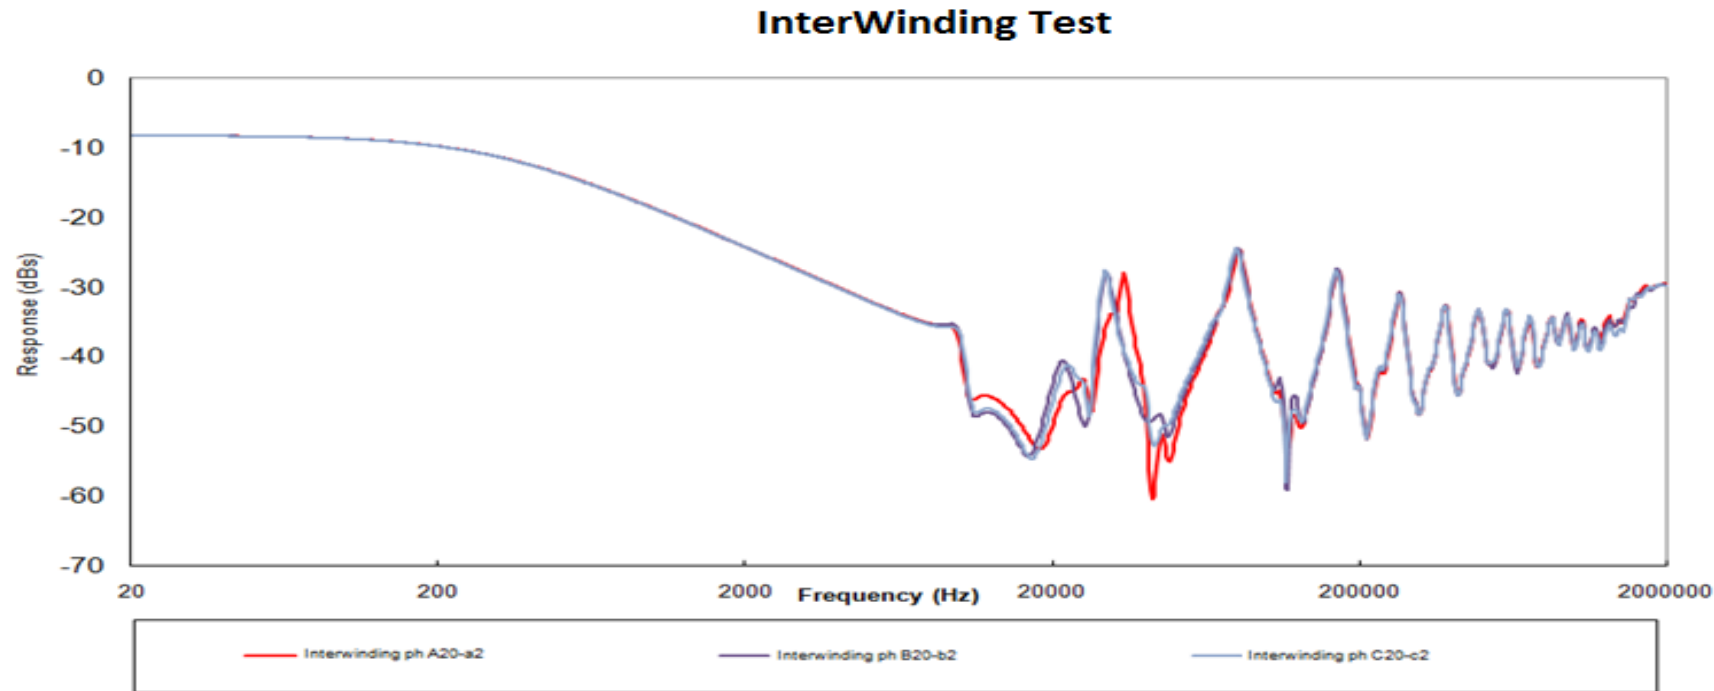
# Movement of Single Turns

So is this a good transformer? It tripped from service due to flashover across contacts of A phase OLTC selector.

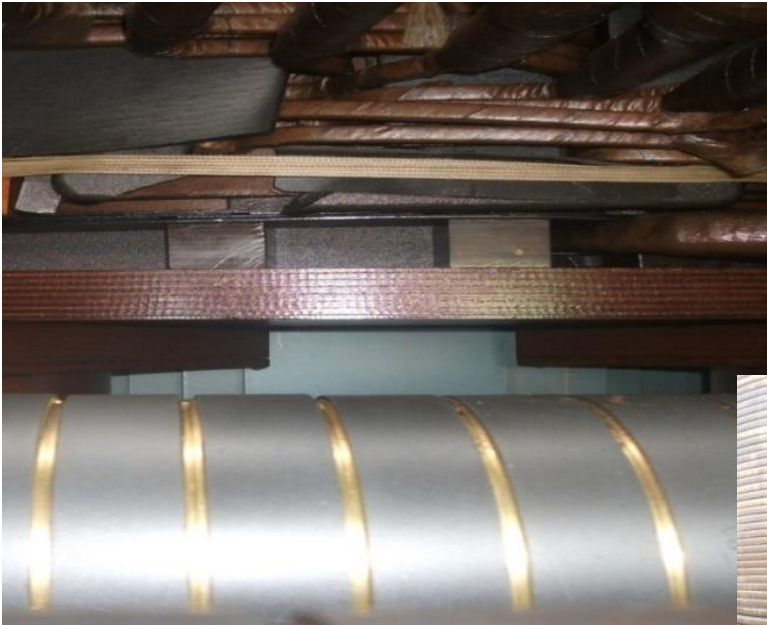
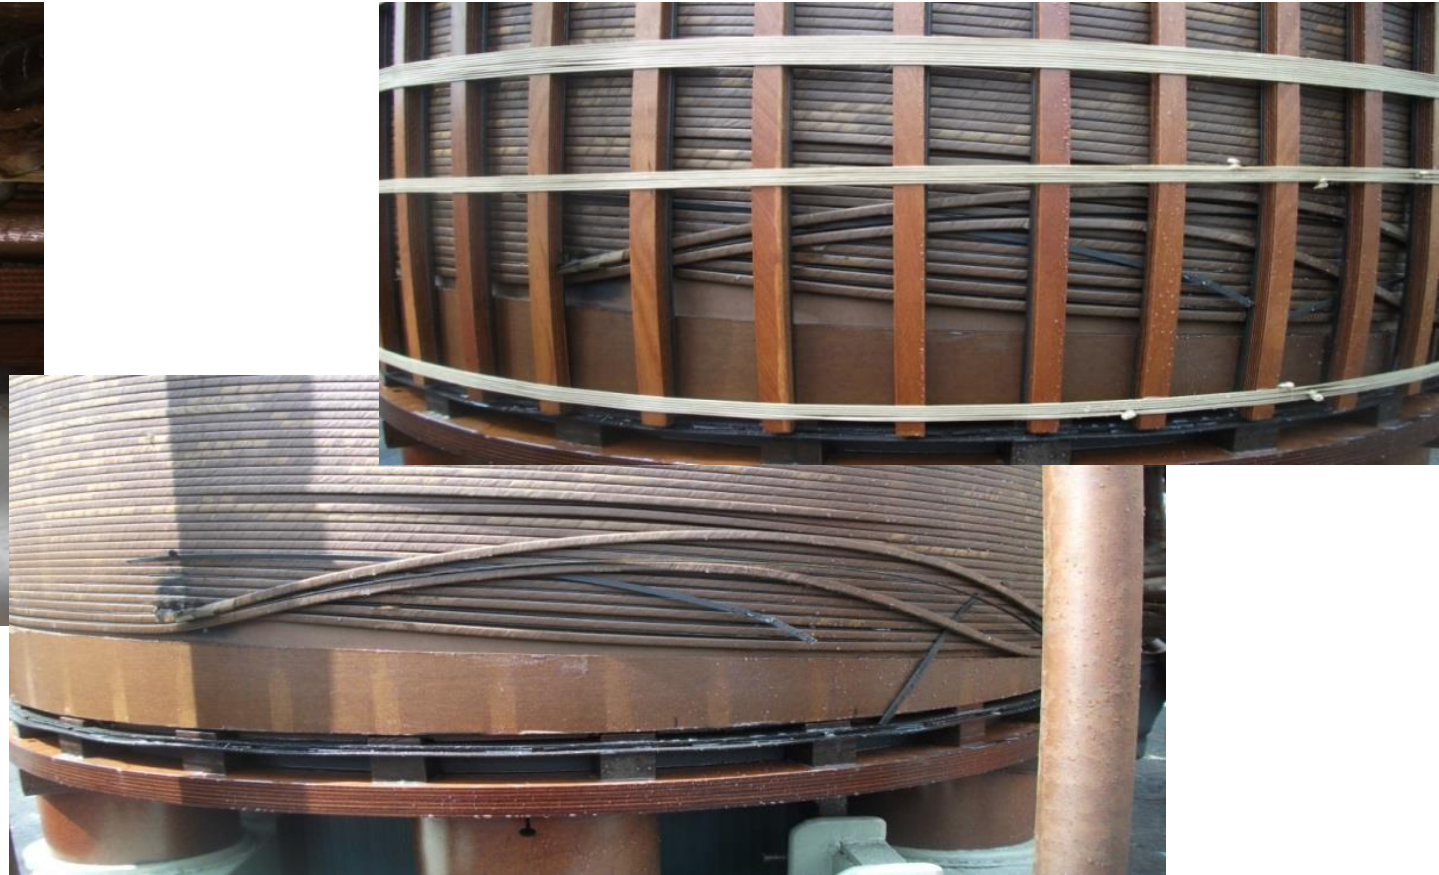
# Movement of Single Turns

Luckily it was possible to see damage through inspection hole.  
Scrapping confirmed slight winding deformation on A phase

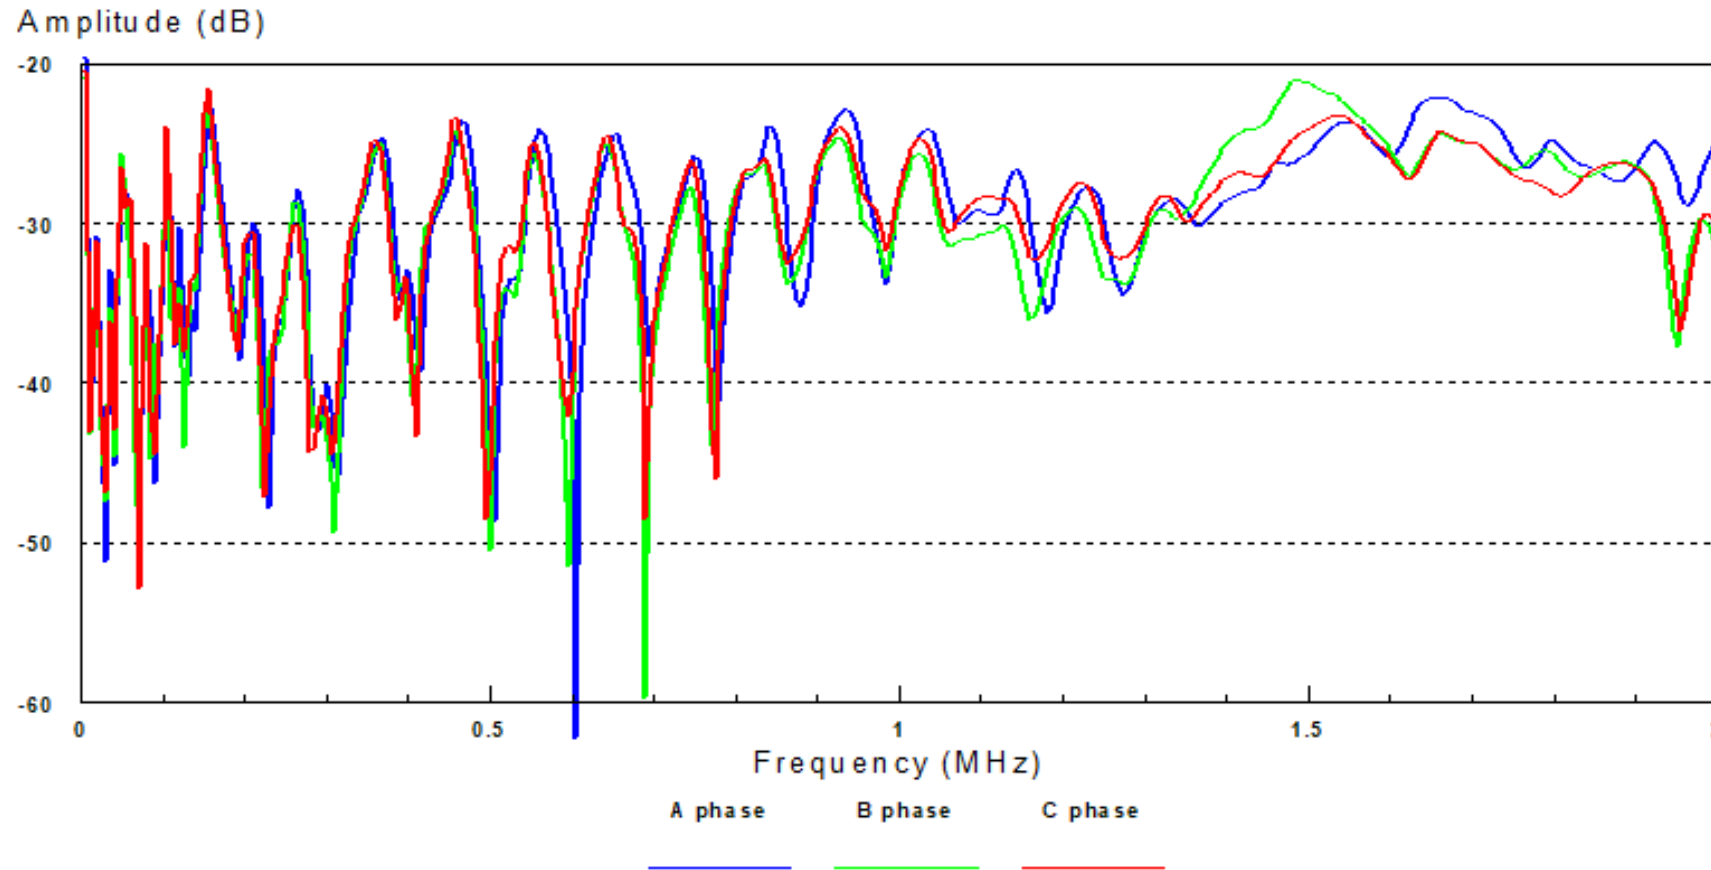
8 / 1 1 / 0 1

35 year old 400/132 kV 240 MVA auto-transformer

**Buchholz alarm**

Analysis of **Buchholz gas** and **main tank oil** indicated **serious fault**

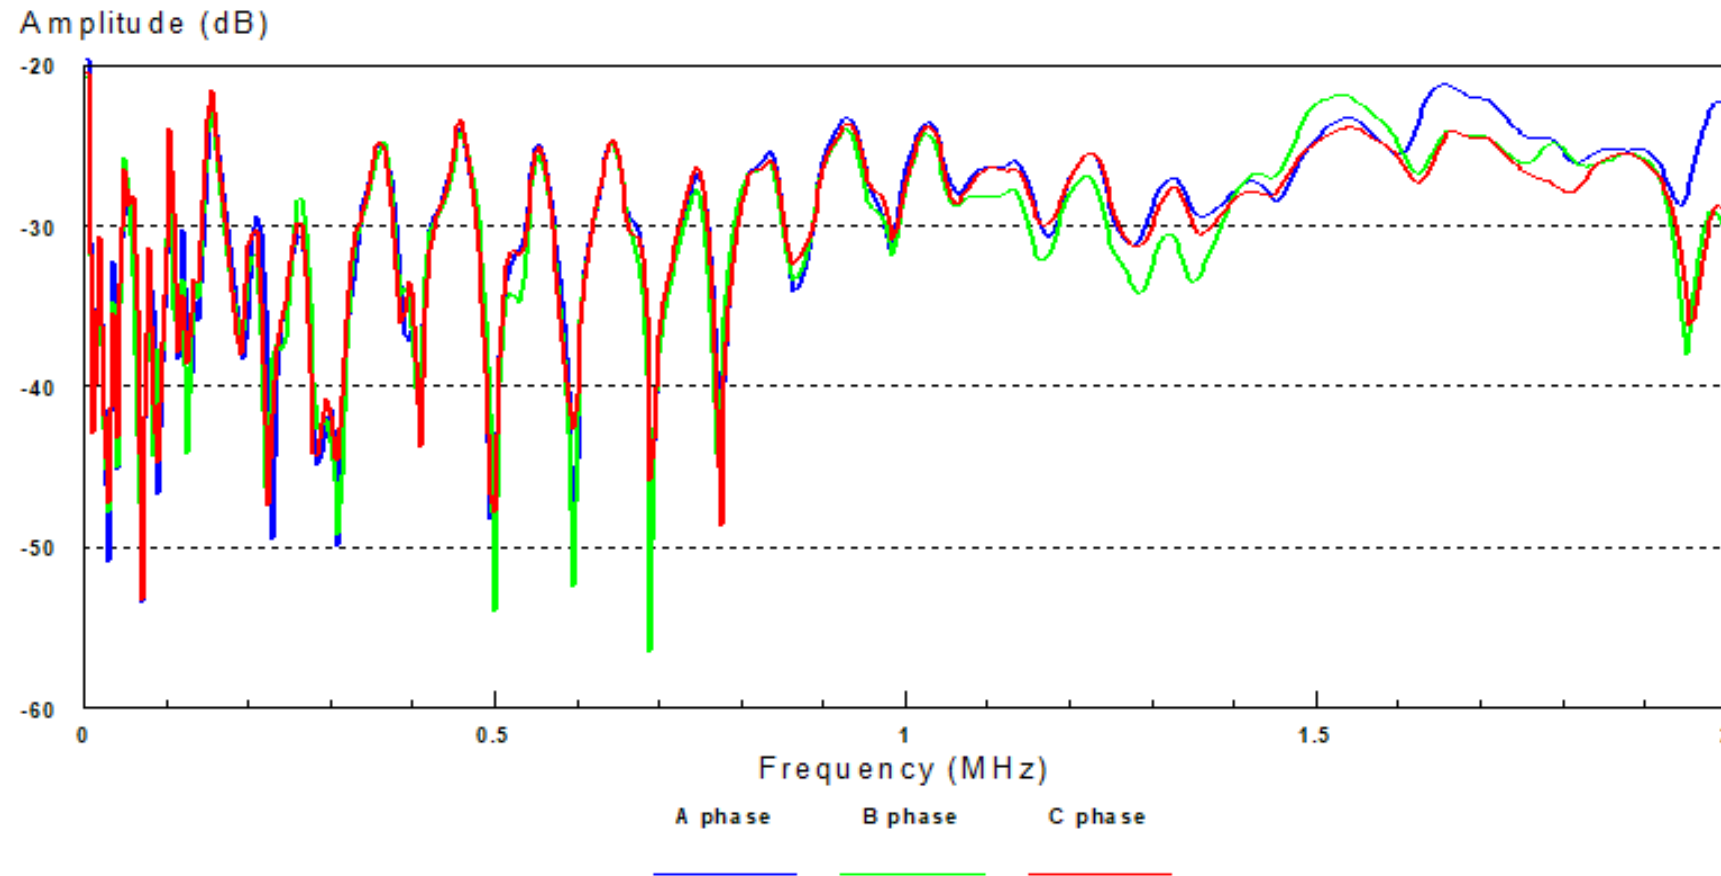
22/11/94

Previous results

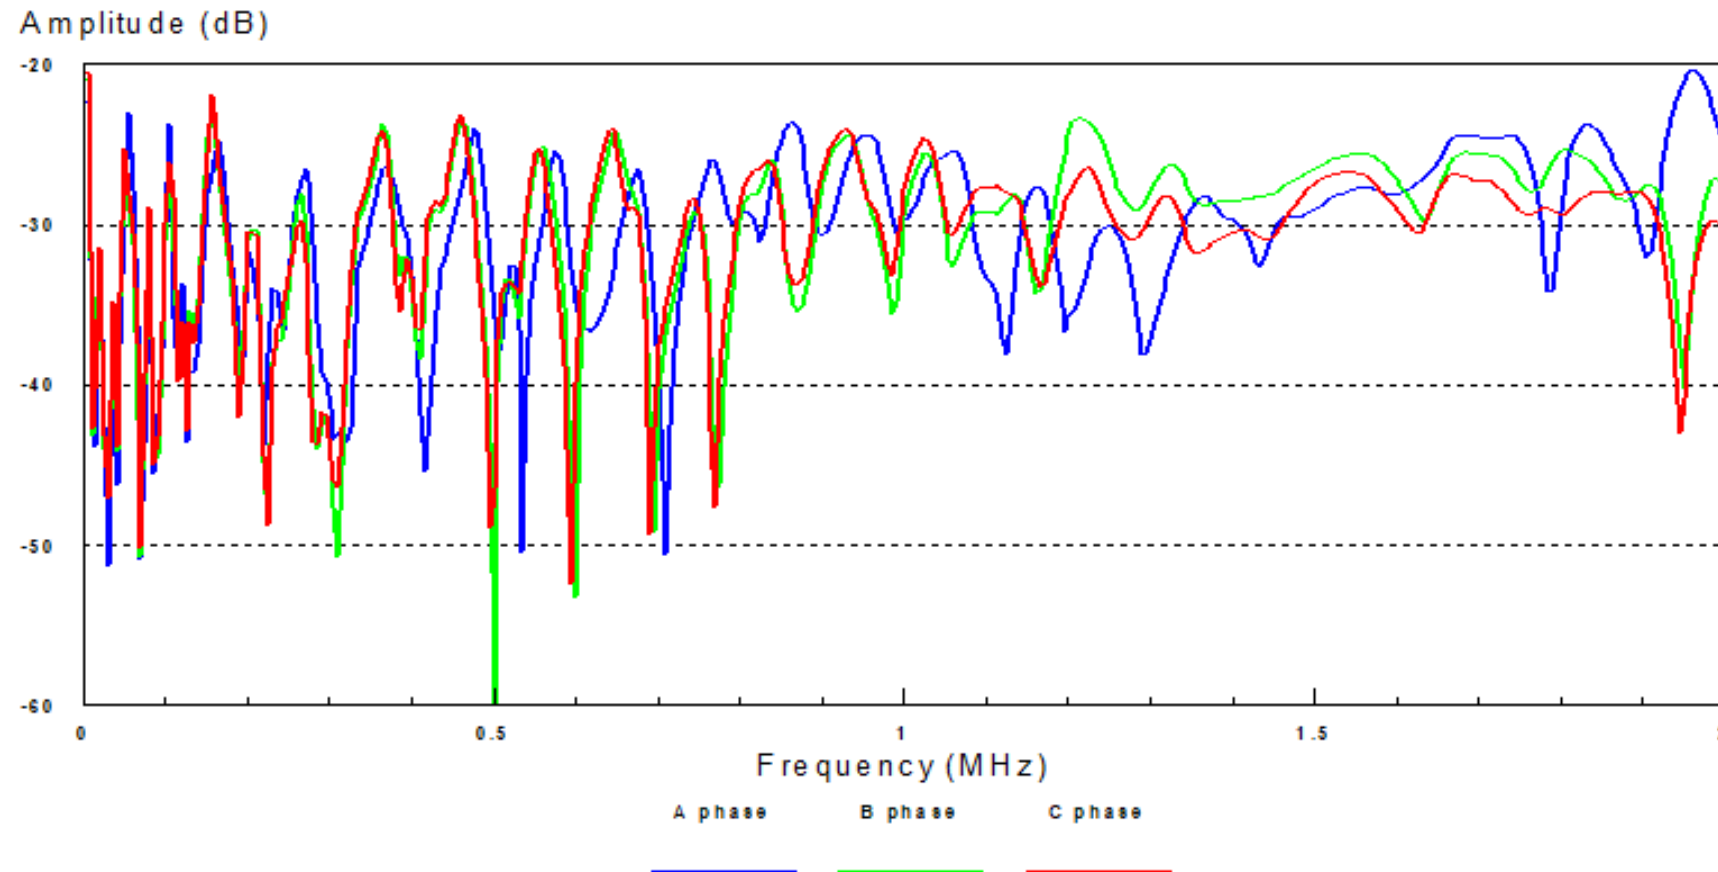
28/07/94

Sister unit failed in service

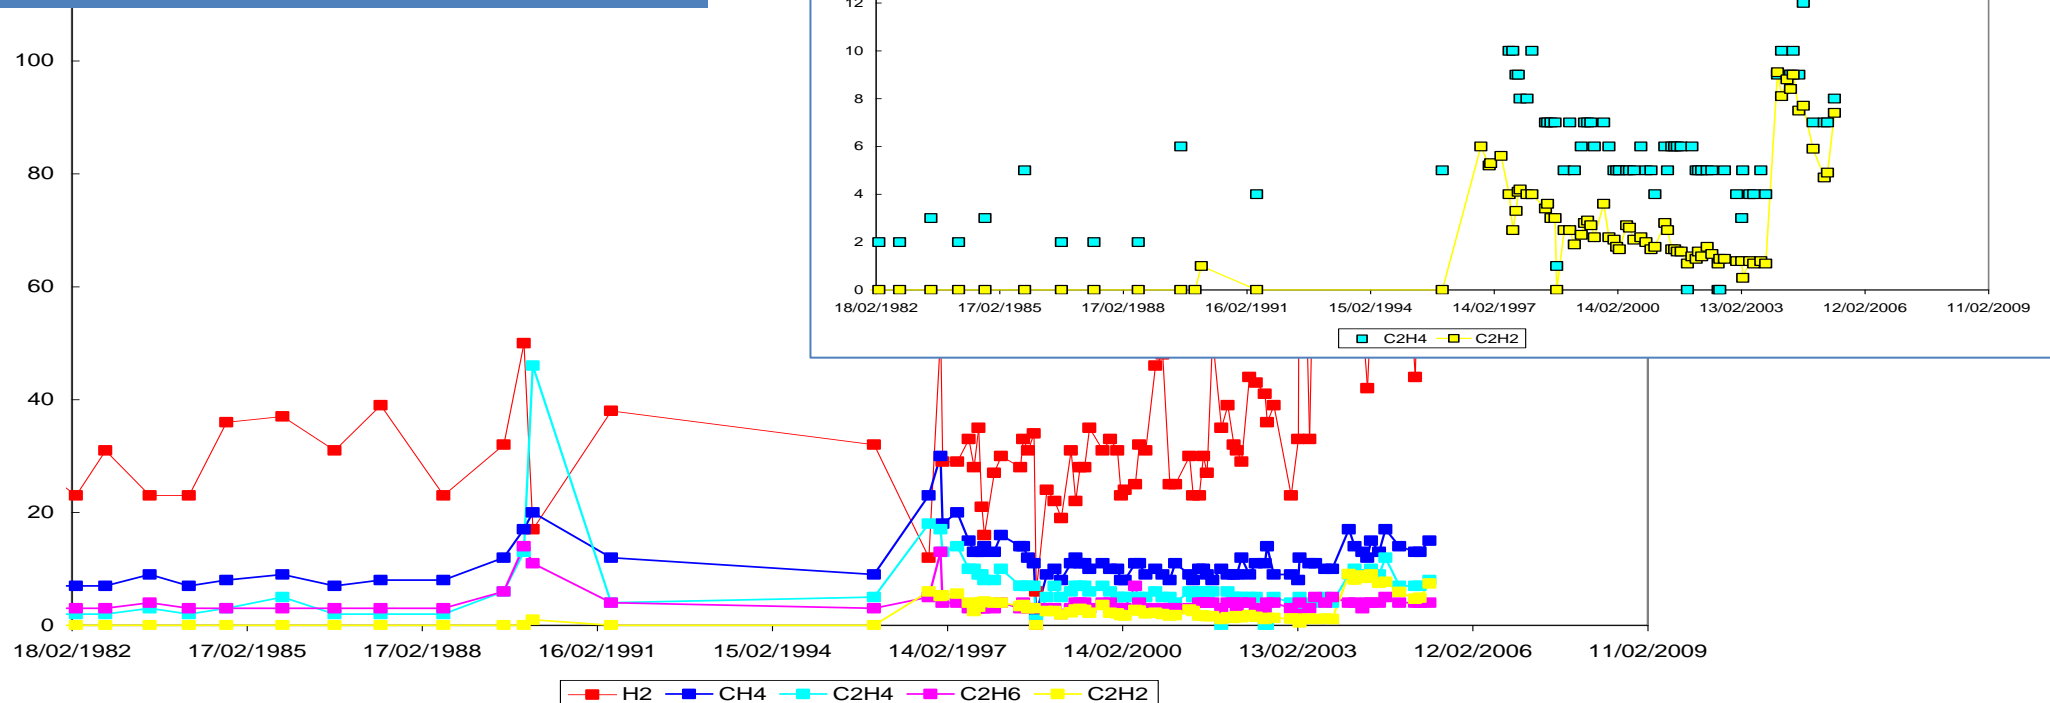
One of gas increases coincided with CT failure

DGA showed three potentially damaging events

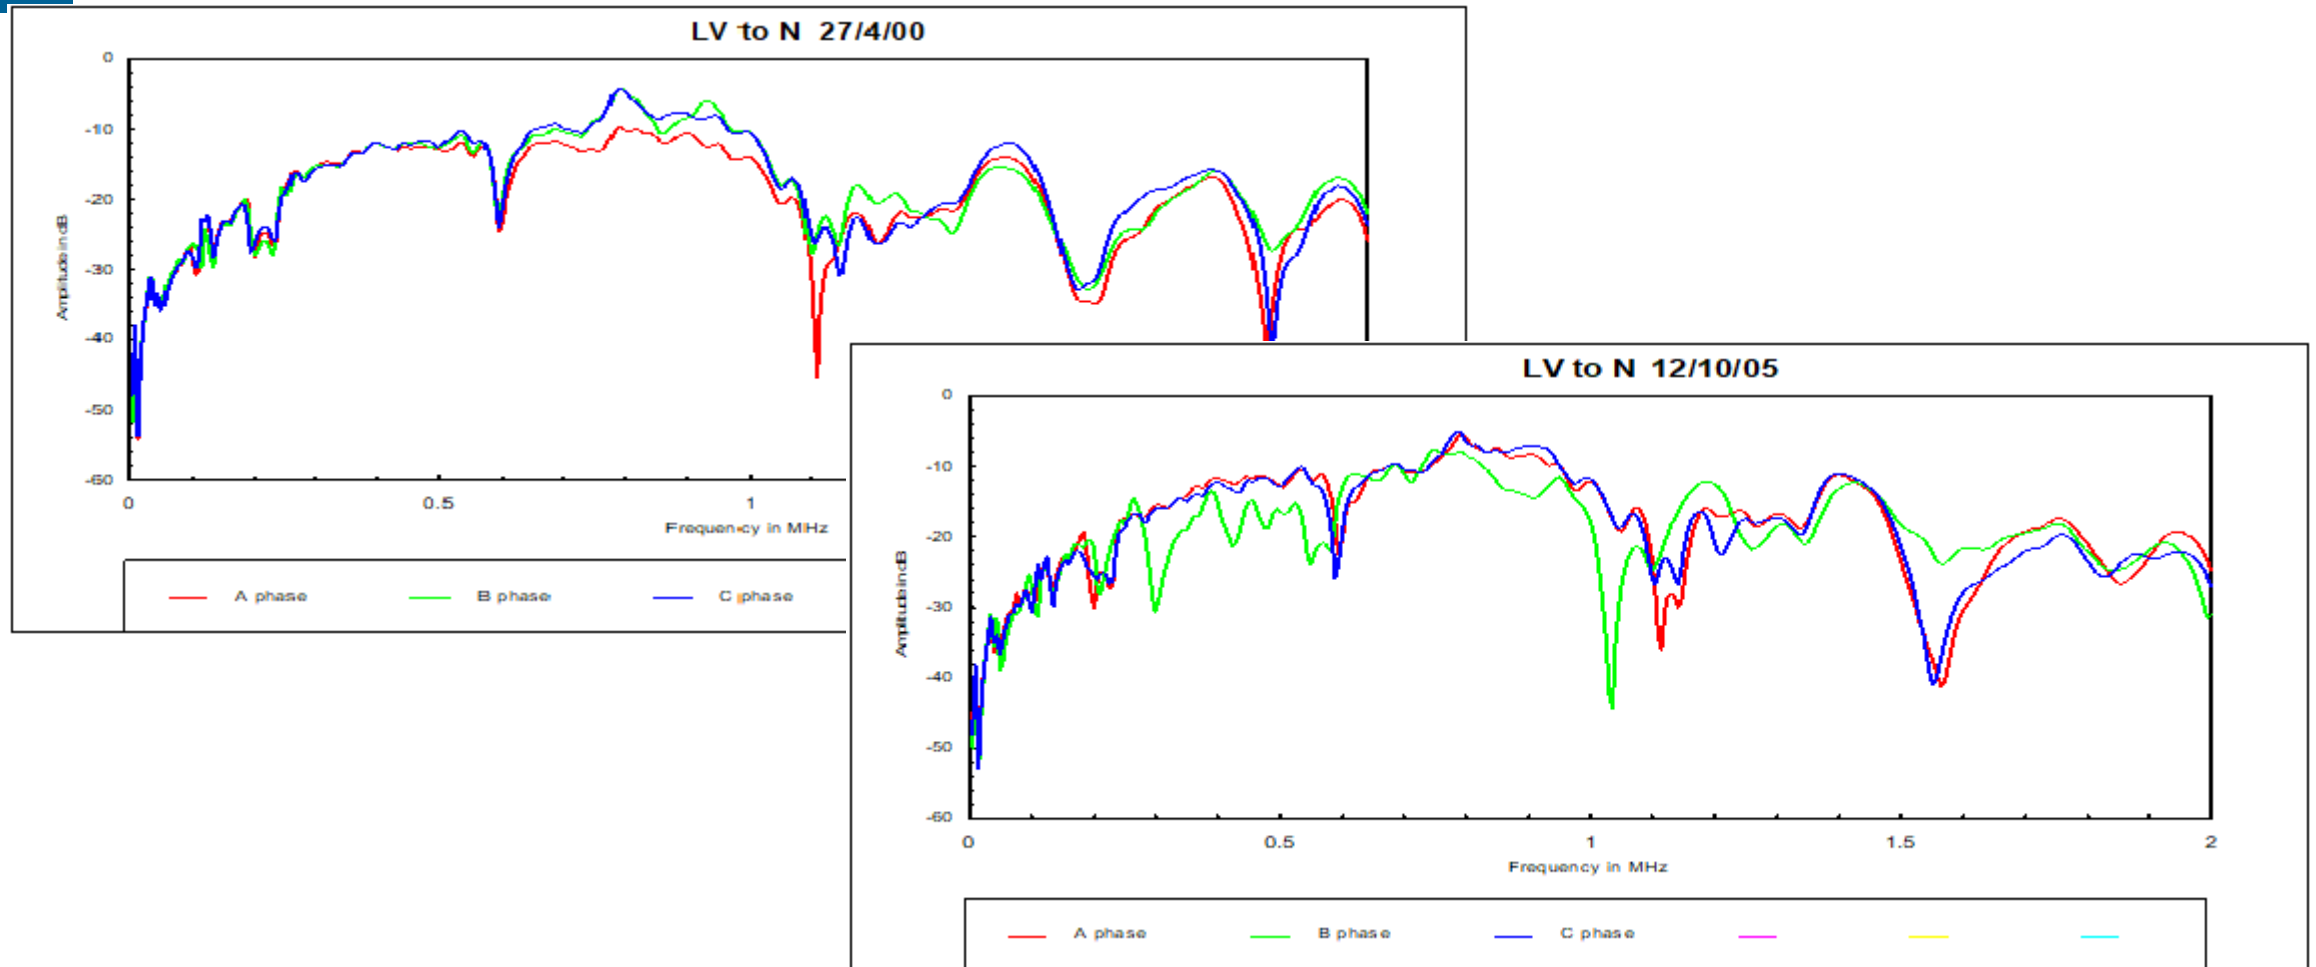
Significant difference in capacitance and power factor were noted for phase B

Also a significant difference in frequency response was noted for phase B

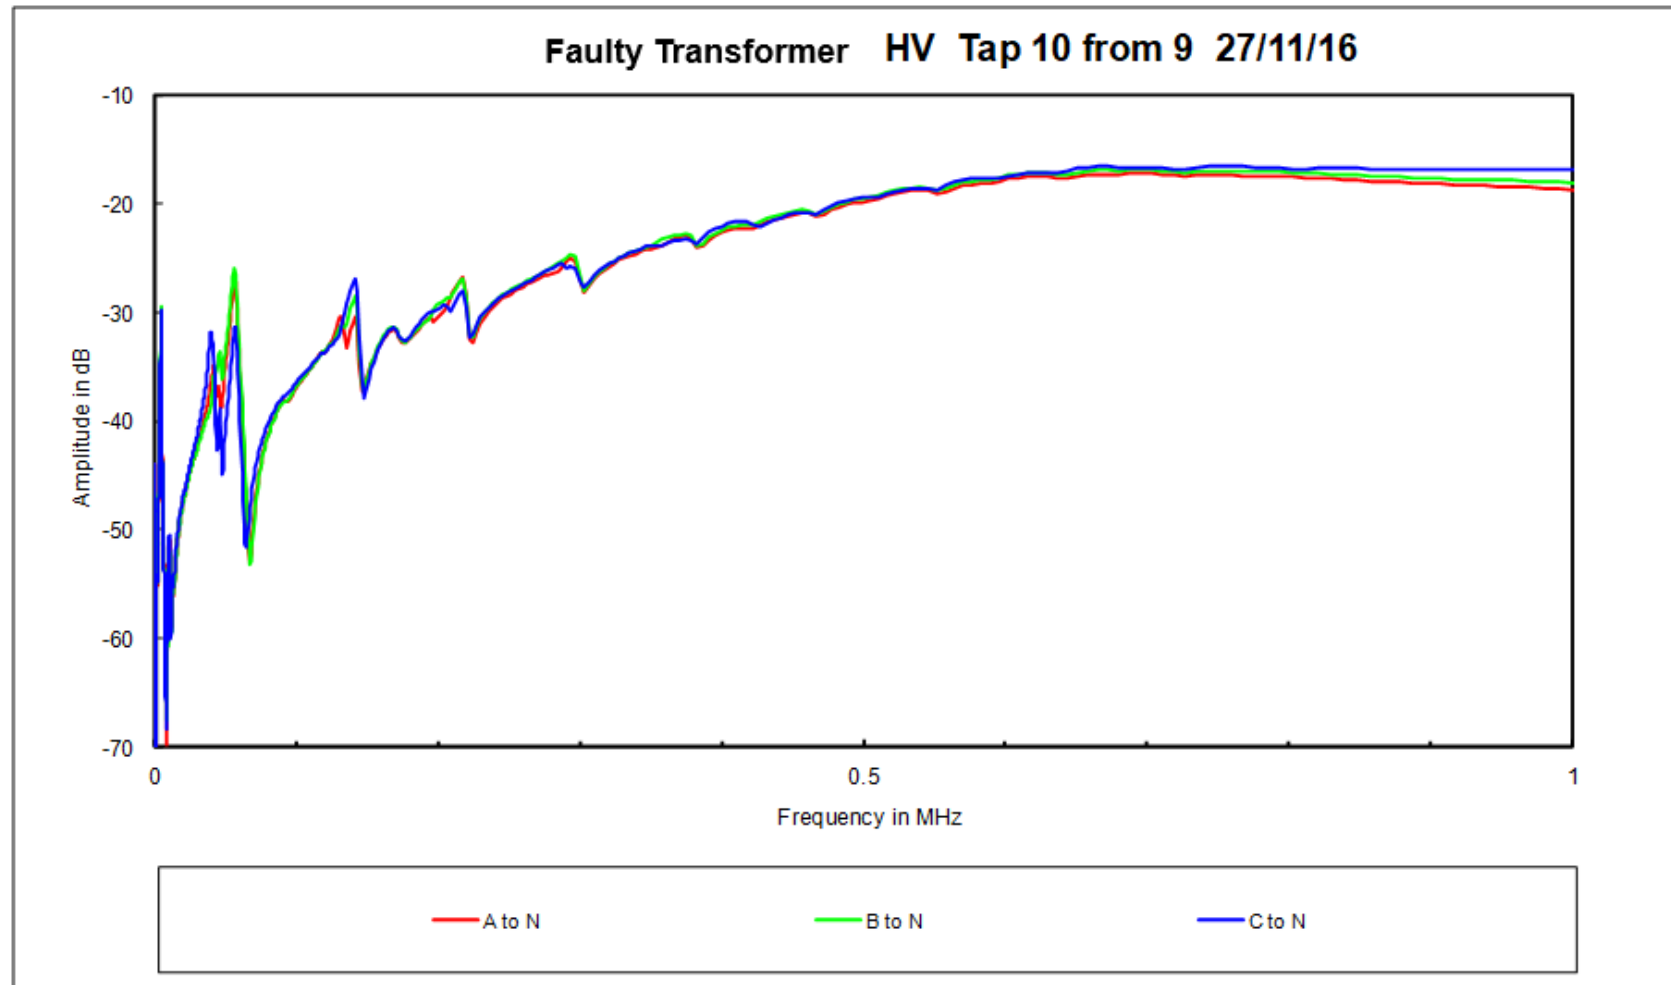
# Tap 10 HV SFRA for faulty transformer

- 275/33kV 120MVA YNd1 transformer feeding steelworks suffered flashover between taps while on 'hot standby'
- Barrier board between tap-changer and main tank broken
- SFRA tests indicated movement for tap winding:
  - ✓ **Difference for Blue phase at Tap 1 (taps 'all-in'), but not at Tap 10 ( 'all-out')**
  - ✓ **Compared responses with sister reference transformer**
  - ✓ **Note faulty transformer was without oil, while reference was oil filled**
- Internal inspection confirmed conductor tilting for Blue phase tap winding
- Special SFRA Tests showed possibility of internal resonant over-voltage between taps involved in flashover for switching surge at HV line terminal
