# Practical Experience with SFRA Technique

Rafal Zaleski  
Principal Transformer Engineer  
Doble Engineering

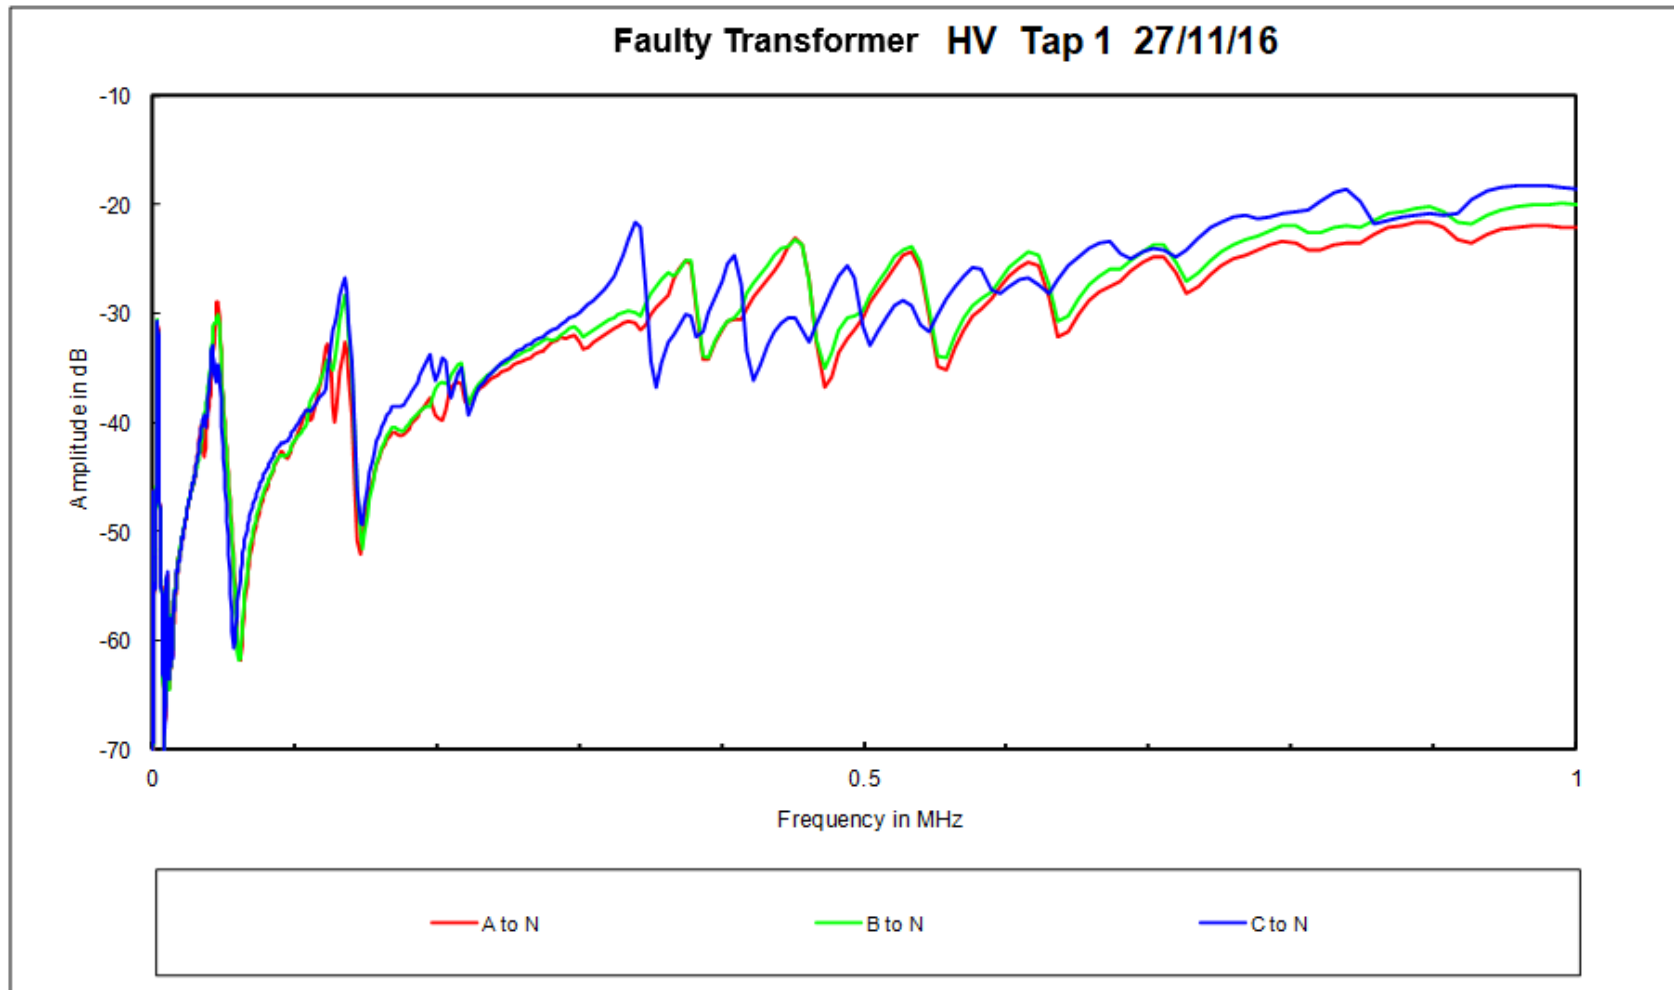
# Tap 1 HV SFRA for faulty transformer

- 275/33kV 120MVA YNd1 transformer feeding steelworks suffered flashover between taps while on 'hot standby'
- Barrier board between tap-changer and main tank broken
- SFRA tests indicated movement for tap winding:
  - ✓ **Difference for Blue phase at Tap 1 (taps 'all-in'), but not at Tap 10 ( 'all-out')**
  - ✓ **Compared responses with sister reference transformer**
  - ✓ **Note faulty transformer was without oil, while reference was oil filled**
- Internal inspection confirmed conductor tilting for Blue phase tap winding
- Special SFRA Tests showed possibility of internal resonant over-voltage between taps involved in flashover for switching surge at HV line terminal

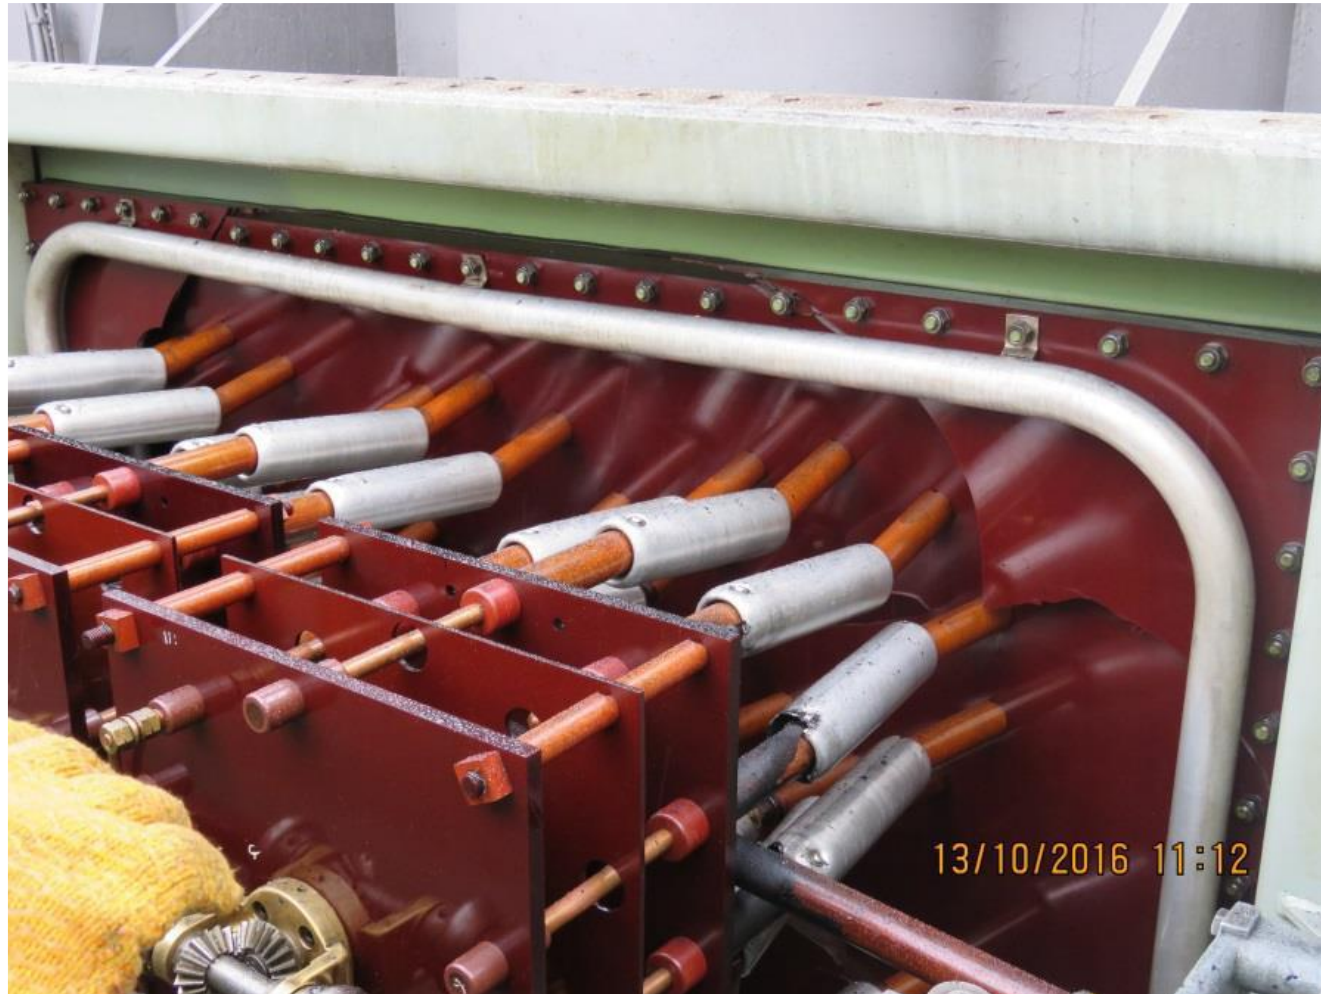
# Broken tap-changer barrier board

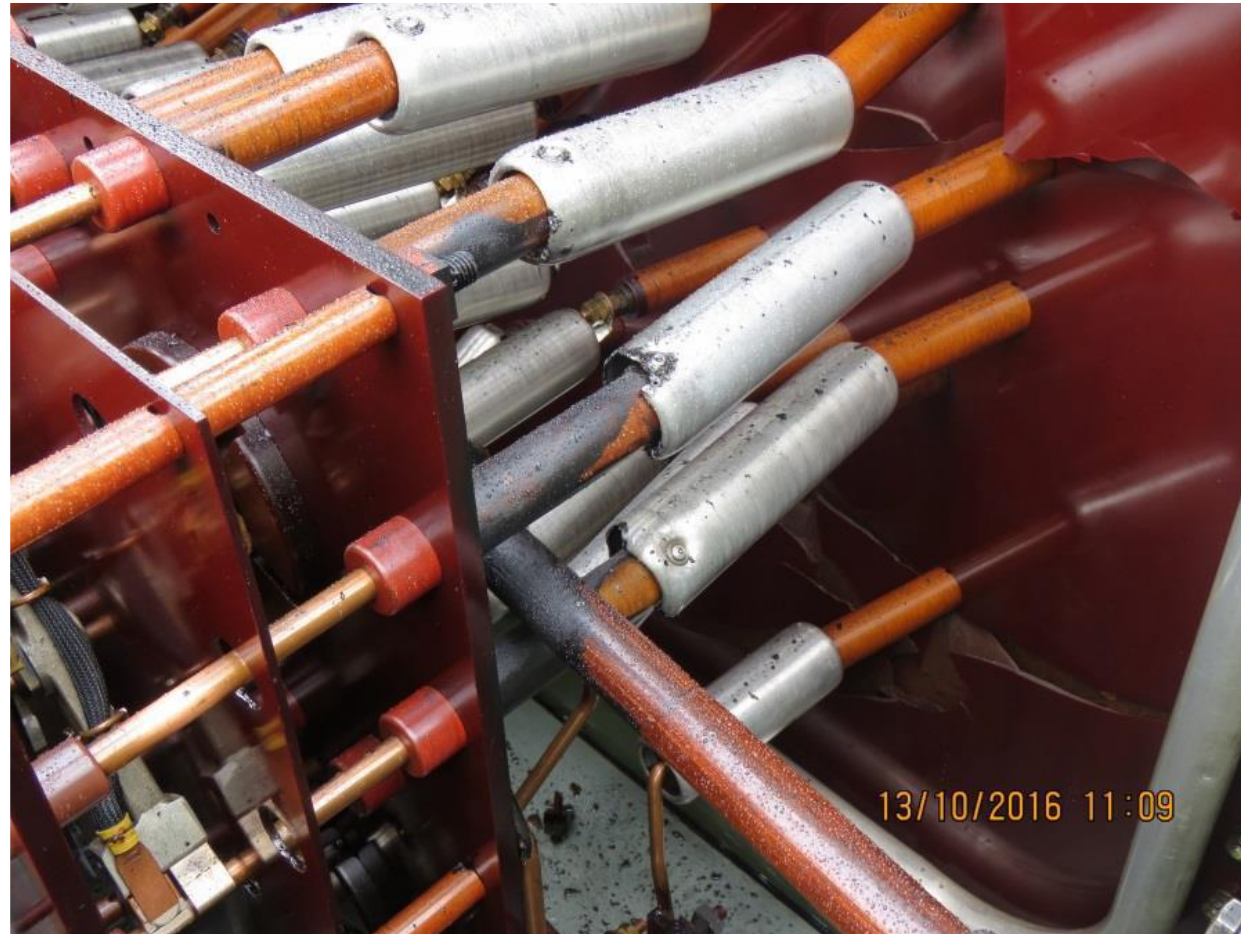
# Flashover damage between Blue phase tap leads
